# Corrosion resistance of Ni-50Cr HVOF coatings on 310S alloy substrates in a metal dusting atmosphere

J. Saaedi\*, H. Arabi, T. W. Coyle, S. Mirdamadi and H. Ghorbani

Metal dusting attack has been examined after three 168 h cycles on two Ni-50Cr coatings with different microstructures deposited on 310S alloy substrates by the high velocity oxy-fuel (HVOF) thermal-spray process. Metal dusting in uncoated 310S alloy specimens was found to be still in the initiation stage after 504 h of exposure in the 50H<sub>2</sub>:50CO gas environment at 620 °C. Dense Ni-50Cr coatings offered suitable resistance to metal dusting. Metal dusting was observed in the 310S substrates adjacent to pores at the interface between the substrate and a porous Ni-50Cr coating. The porosity present in the as-deposited coatings was shown to introduce a large variability into coating performance. Carbon formed by decomposition of the gaseous species accumulated in the surface pores and resulted in the dislodgement of surface splats due to stresses generated by the volume changes. When the corrosive gas atmosphere was able to penetrate through the interconnected pores and reach the coating–substrate interface,

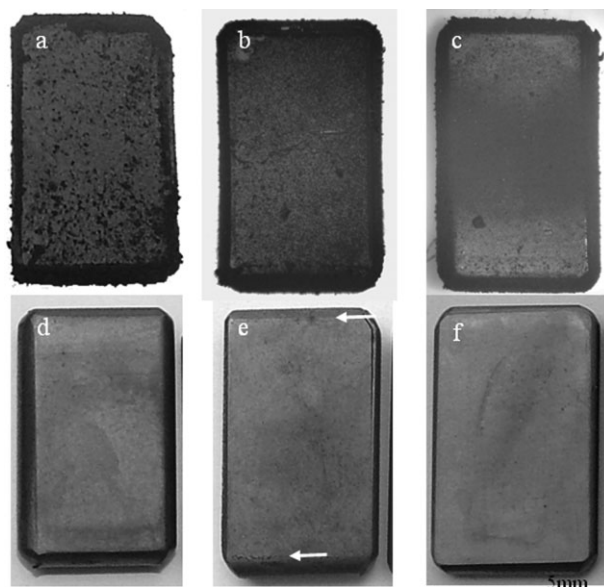
After 168 h exposure the surfaces of the C1 specimen were blackened by carbon and a number of coke nodules were found on its plan surface and edges (Fig. 2a). Carbon deposition smoothly blackened all surfaces of the C2 specimen and partially blackened the surfaces of the uncoated 310S sample (Fig. 2b and c). Some small coke protrusions were noticed on the edges of these specimens.

After removing the non-adhesive powder carbon deposits by ultrasonic cleaning, the specimen's surfaces exhibited light green (for the coatings) and yellow (for the uncoated 310S) interference colors caused by oxidation (Fig. 2d–f). A number of small black spots were seen on the surface of the specimens but no pits were observed. The stability of the coatings and bonding of the coatings to the substrate was generally good. No cracks were observed on

**Figure 2.** The surface morphologies of the C1 (a and d), C2 (b and e), and uncoated (c and f) specimens after 168 h exposure, (a)–(c) before, and (d)–(f) after ultrasonic cleaning

the C1 sample but a small amount of spallation of the coating had occurred at the corners. Further investigations showed that the coating in these areas was already thin because of extra grinding during preparation in order to radius the edge. A ~1 cm crack was observed at the intersection of the plan and side surfaces on one side of the C2 sample (Fig. 2e, upper-right). Small damaged areas were seen along the intersection of the plan and end surfaces of the C2 coating (arrows in Fig. 2e). Further investigation showed that the coating on the end surfaces in these areas was relatively thick (180  $\mu$ m).

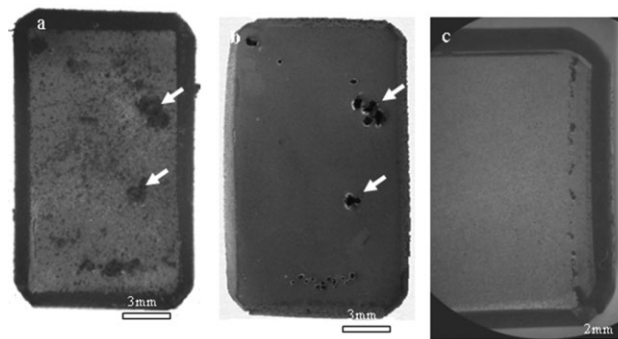
With increasing exposure time, 336 and 504 h, more and more carbon powder deposits covered the surfaces of the specimens; however, the short coke protrusions observed after 168 h along the edges of the specimens had not grown. A few new metal eruptions were observed on the plan surface of the C1 sample after 504 h of exposure underneath the coke protrusions (see arrows in Fig. 3a and b). These kinds of metal protrusions were not found on the surface of sample coating 2, but the corroded areas about 2 mm from the ends of the C2 specimen observed after 168 h were slightly larger after 504 h of exposure (Fig. 3c). The coke protrusions on the surface of the scratched sample of coating 1 were larger after 504 h of exposure.

**Figure 3.** The surface morphologies of the coating system after 504 h exposure: (a) C1 sample before coke removing, (b) C1 sample after coke removing, and (c) C2 sample after coke removing

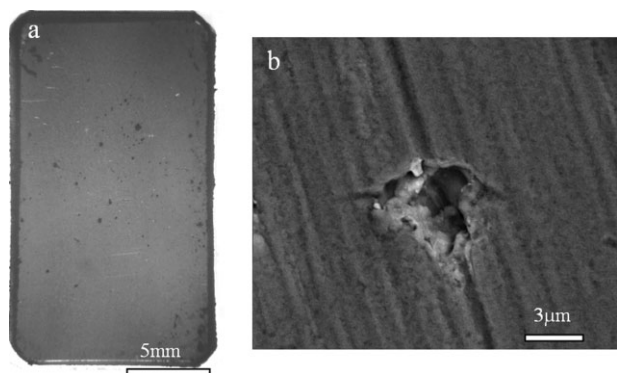
In the case of the uncoated 310S alloy sample the number of black spots increased with further exposure (Fig. 4a). Moreover, damage was occasionally observed in the surface oxide layer (Fig. 4b).

**Figure 4.** The surface morphology of the uncoated 310S sample exposed for 504 h showing: (a) the black spots and (b) a damage in the oxide layer

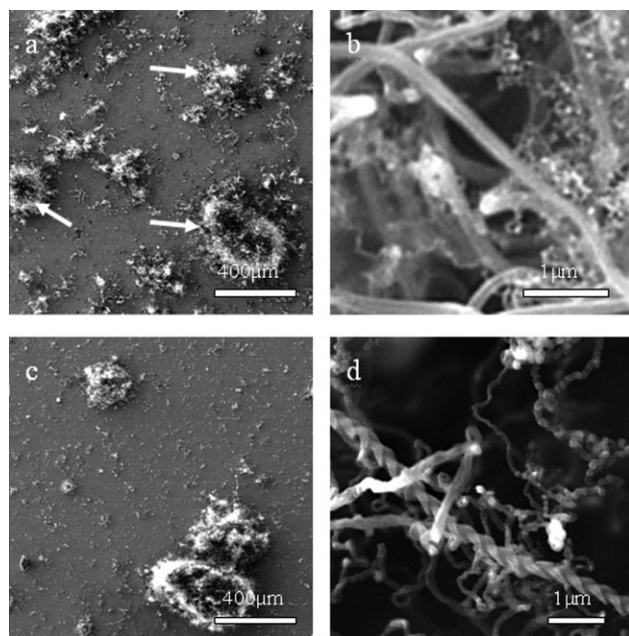
Coke products which formed on the surface of coating 1 are shown in Fig. 5a and b. This type of coke formation is indicative of metal dusting corrosion. Bundles or nests of filamentous carbon were observed on the surface of coatings at higher magnifications

**Figure 5.** Carbon products formed on the surfaces of the specimens which were exposed for 168 h: (a) and (b) C1 sample, (c) and (d) uncoated sample

(arrows in Fig. 5a). These generally consisted of two different size filaments; some with a diameter in the range of 200–500 nm and carbon nanotubes and/or nanofibers with diameters less than 100 nm (Fig. 5b). The appearance of these filaments is consistent with growth via catalysis of carbon deposition by metallic nanoparticles at the filament tips.

Figure 5c and d presents images of coke products formed on the surface of an uncoated 310S sample. The coke bundles deposited on the surface of this specimen also included carbon fibers and carbon nanotubes and/or nanofibers. Fiber morphologies which were different than those seen on the surface of coatings were observed. Some of the fibers seemed to be made up of a string of spherical particles.

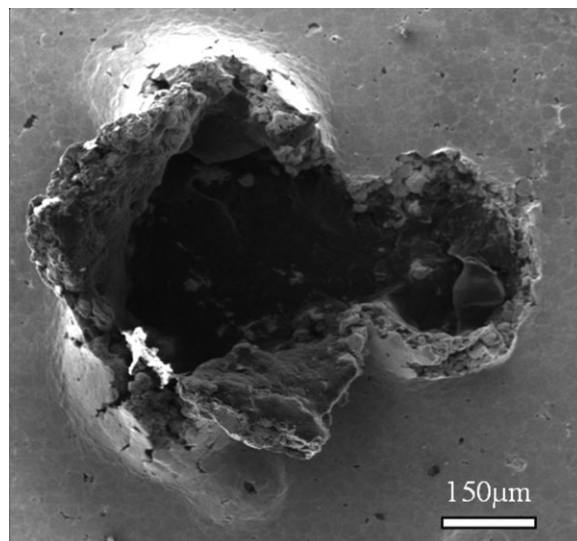
**Figure 6.** Local eruptions on the surface of coating 1 after 504 h exposure

Figure 6 shows higher magnification images of some of the metal protrusions observed on the plan surface of sample C1 in Fig. 3b. It seems that they developed following the formation of corrosion products in the subsurface pores, resulting in local eruptions through the coating due to stresses generated by the volume changes. Pre-existent surface pores are also visible in these figures, which provided paths for the penetration of the corrosive gas into the coating. The interior of the erupted areas was filled with coke. Dislodged metallic fragments embedded in the carbon deposits can be seen.

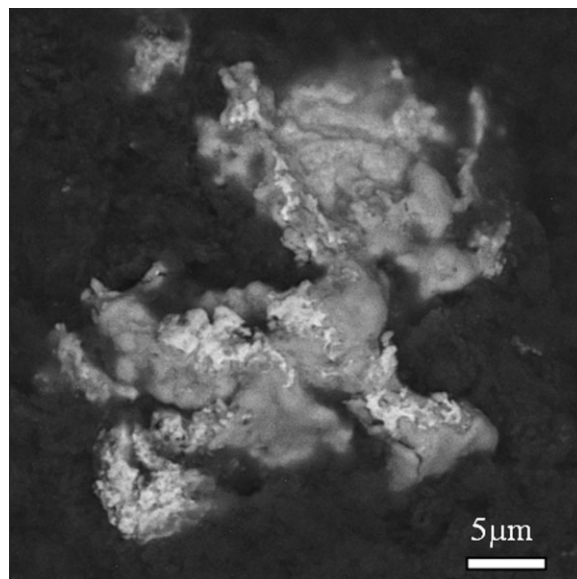
**Figure 7.** SEM image of a dislodged fragment embedded in the carbon deposits inside a damaged area on the surface of coating 1 after 504 h exposure

A backscattered electron (BSE) image of a metallic fragment inside the corroded area shown in Fig. 6 can be seen in Fig. 7. It

had a size of 10–15  $\mu\text{m}$ . Most of this fragment consisted of a light gray contrast phase and a white phase. An EDS semi-quantitative analysis of this particle showed that it consisted of 42Cr–31Ni–13O–9C–2.8Si–1.25Fe–0.52Al (wt%), indicating that this fragment had separated from the coating. The high O content would suggest that the light gray region is an oxide phase. The relatively high Si and Al contents in the chemical composition of this fragment may be associated with incorporation of these elements in the oxide. The size of the particle suggests that this fragment was part of an oxide layer on the surface of the original powder particle or which formed on a splat during deposition. The carbon detected is likely due to the surrounding carbon deposits.

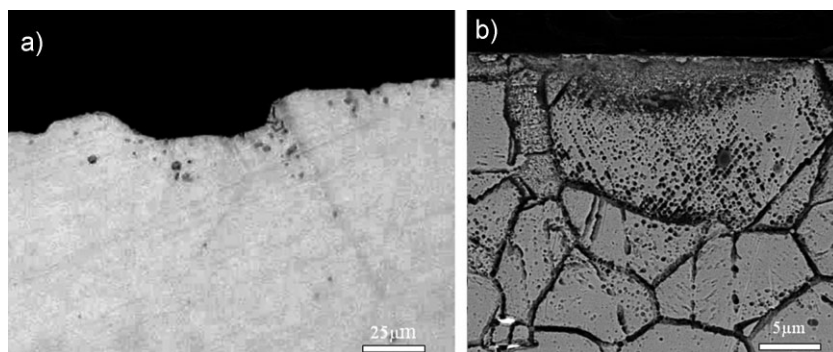
**Figure 8.** Metallographic cross-sections from the black spots which were formed on the surface of uncoated specimens for: (a) 504 h (optical micrograph), and (b) 168 h (BSE micrograph) exposures

In areas where black spots were observed, the underlying damage was examined in cross-section. Metallographic cross-sections confirmed that the surface oxide film which was formed during exposure was rarely damaged and protected the underlying alloy against metal dusting attack over nearly the entire surface. The few black spots observed on the plan surface after ultrasonic cleaning were found to be very shallow, irregular pits which were filled with adherent carbon deposits and/or oxides (Fig. 8a). These spots were observed after 168 h of exposure but had still not developed into well-formed pits after 504 h.

A BSE image of a cross-section of another small black spot from the specimen exposed for 168 h can be seen in Fig. 8b. The pit was initiated near the center of a large grain. The damage did not extend more than one or two grains. Carburization of the grain and formation of carbide precipitates underlying the pit could be observed after etching of the cross-section.

The shallow craters under the black surface spots on the uncoated 310S alloy were contained within large grains beneath which numerous intragranular carbide precipitates were formed (Fig. 8b). The small coke nodules which formed over these spots included carbon fibers (Fig. 5c and d), indicating that metal dusting had initiated in these isolated locations, but had not fully developed after 504 h. This view is consistent with the observed weight change kinetics. Hence it could be said that the oxide film formed on the surface of the 310S alloy in an atmosphere with a  $\text{CO}/\text{H}_2$  ratio of 1 protected the underlying alloy for at least 504 h. Thermal cycling is believed to accelerate the degradation due to the formation of cracks in the oxide film. There was no evidence that the three cycles down to RT during the 504 h exposure produced such an effect.

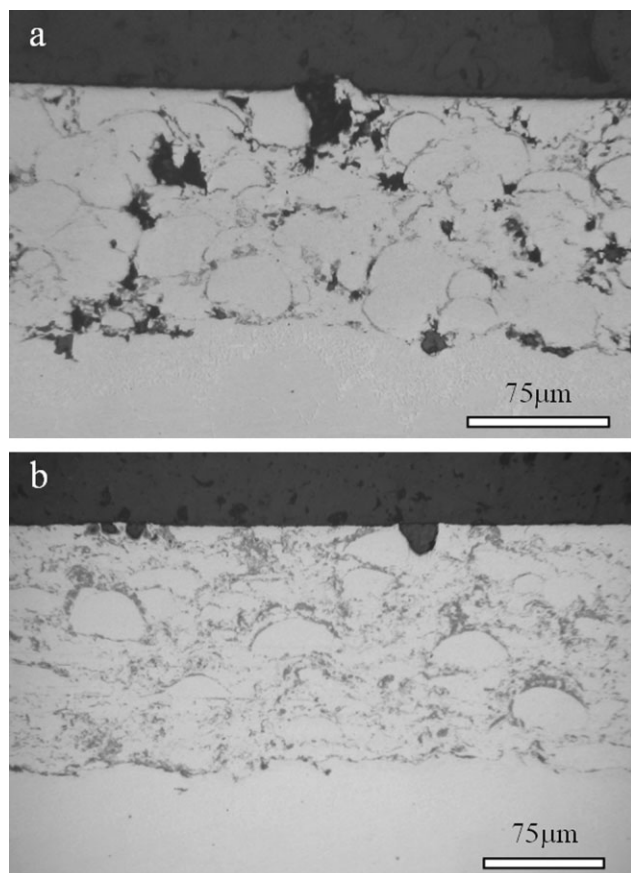
OM investigations from cross-sections of C1 and C2 specimens after 168 h exposure showed that the coatings preserved the initial smooth surface topography in most areas. The surface damage was restricted to the large or interconnected pores (Fig. 9). Deposits of carbon products were observed inside these pores. The number of damaged spots on the surface of the C2 sample, which is the denser coating, was much less and their size was smaller than on the C1 sample.

**Figure 9.** OM images of the coating systems after 168 h exposure: (a) C1 and (b) C2 samples

The C2 coating was very dense, which limited carbon penetration to pores located at the surface (Fig. 9b). The adhesion of this coating to the substrate was generally very good; no spallation occurred on the plan surfaces. However, a crack was observed near the intersection of the plan and side surfaces, where the coating thickness ranged from 150 to 180  $\mu\text{m}$  (Fig. 21), probably due to stresses generated by the CTE mismatch between the substrate and coating. Defects in the coating were also observed in the plan surface near the end of the specimen where again the coating thickness was greater than 150  $\mu\text{m}$  (Fig. 3c). At such defects, the reactive atmosphere penetrated the coating to reach the substrate. The attack of the substrate resulted in the damage seen on the coating surface after the 168 h exposure. These results indicate that the C2 coating system itself had not undergone metal dusting by 504 h.

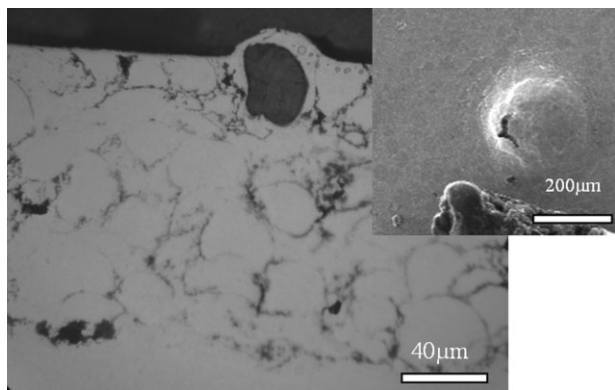
Some of these pores had been completely filled with dense carbon deposits, which were not removed by the ultrasonic cleaning treatment. In some areas carbon ingress took place through the surface pores and penetrated into the intersplat pores. The formation of carbon deposits beneath or around surface splats led to deformation (Fig. 10) or separation (Fig. 11) of the splats.

**Figure 10.** OM image showing the accumulation of carbon in a subsurface pore and deformation of the overlying splat in the C1 sample exposed for 504 h. A bulged area on the surface is seen in the small SEM image (upper-right)

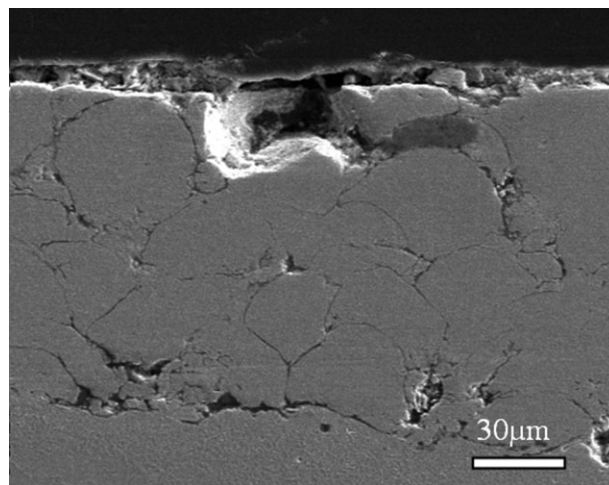
**Figure 11.** SEM image showing carbon deposits in intersplat pores and separation of a surface splat in the C1 sample exposed for 504 h

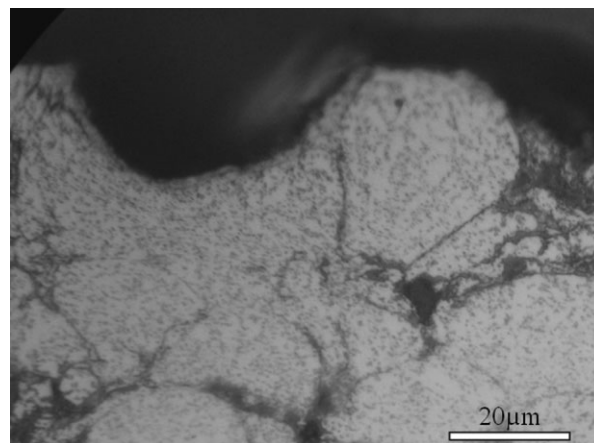
There was no clear evidence of carburization of the coating alloy; no carbide precipitates were observed within the splats after etching (Fig. 12). The microstructure within the splats consisted of the fcc  $\gamma$ -Ni matrix with bcc  $\alpha$ -Cr precipitates as expected from the equilibrium phase diagram and previously observed after heat treatment at 650 °C in a vacuum condition [18].

**Figure 12.** OM image after etching from a damaged area and underlying material of the C1 specimen exposed for 504 h

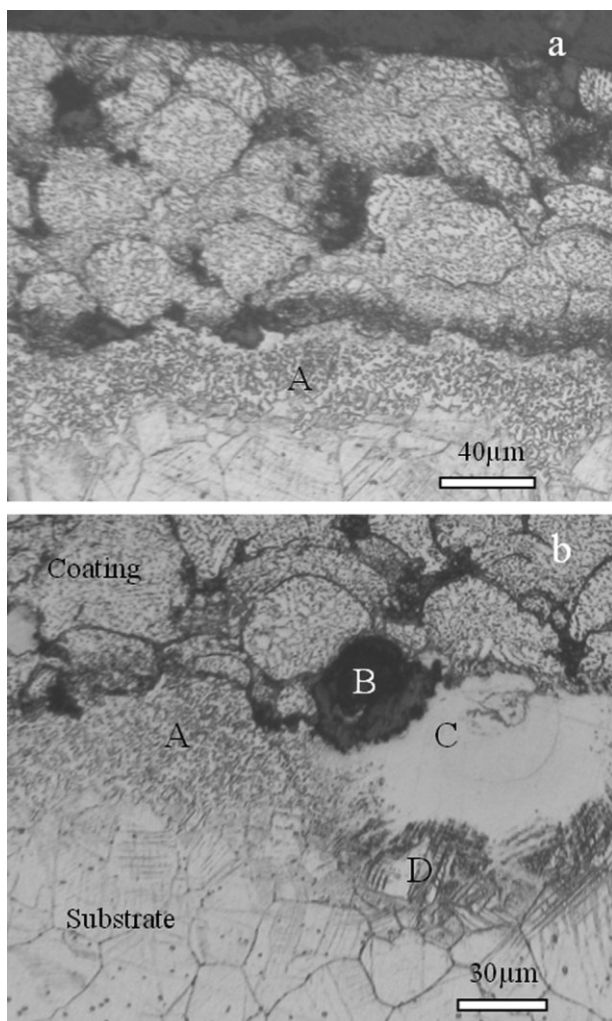
carburization products were observed on the substrate side of the interface after etching: a uniform structure about 50  $\mu\text{m}$  in depth (labeled A in Fig. 13) which was also observed in C2 specimens, and a needle shaped or lamellar structure (labeled D in Fig. 13) under a non-etching white zone (labeled C in Fig. 13). Such structures (areas C and D) were not seen at the coating/substrate interface of the exposed C2 specimen. As mentioned above, the as-deposited C2 coating did not have an interconnected pore structure.

The extent of the areas of uniform structure and white zones in the interface of the C1 coating system increased with exposure time. Non-etching white zones were observed beneath extended coke-filled pores in the C1 specimens exposed for 336 and 504 h, area B in Fig. 13b. Formation of masses of coke inside these pores led to local eruptions in the coating surface and growth of coke protrusions on the surface (Fig. 14) in some areas. The reactant gases could reach the substrate through the pre-existing interconnected pore structure (or through pores which became

**Figure 13.** (a) Formation of a uniform interdiffusion structure in the substrate under the interface, area A, (b) a needle-like structure underlying a white zone beneath the extended coke-filled pore, areas C and D

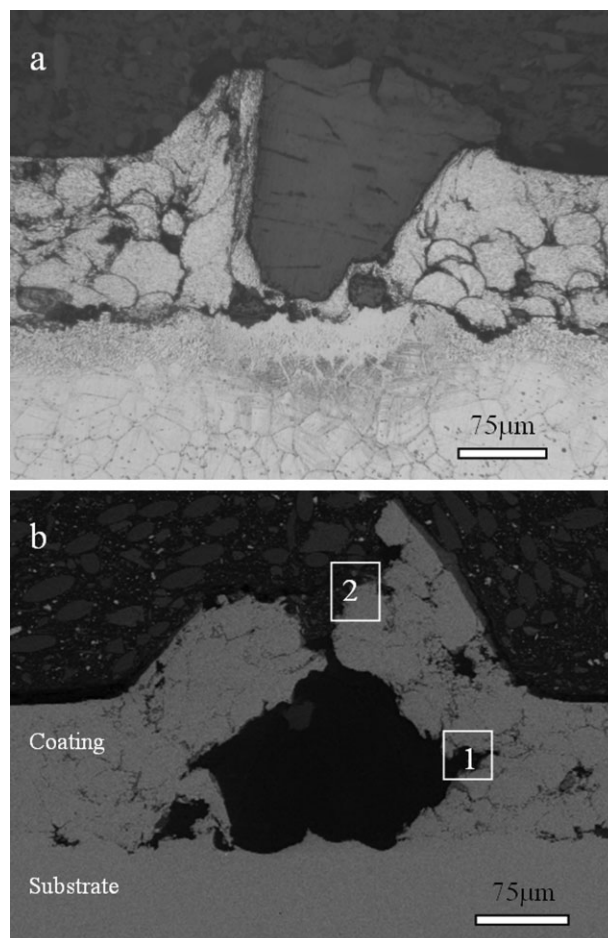
interconnected during exposure). The formation of carbon deposits at the coating/substrate interface suggests that metal dusting of the substrate occurred, and that the stresses generated by the volume changes led to the eruptions observed in the coating surface.

**Figure 14.** Formation of masses of coke inside the extended pores and eruption of coating surface in the C1 coating system after 504 h exposure, (a) OM image and (b) SEM image

The metallographic cross-sections of coating C1 revealed that the reactive atmosphere was able to reach the coating/substrate interface through the interconnected pores within the coating (Figs. 13–15). Semi-spherical non-etching white zones were observed adjacent to extended coke-filled pores which grew along the interface. Formation of this characteristic non-etching zone was accompanied by attack on the underlying steel, showing that the structure provided little or no protective effect. It seems that these areas were undergoing metal dusting.

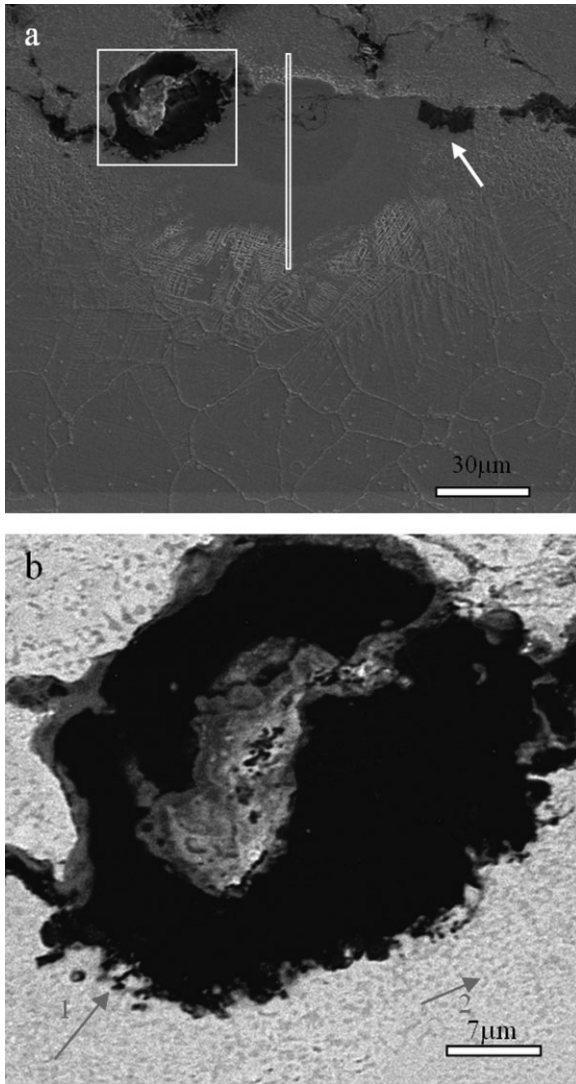
Higher magnification SEM images of the areas B and C in Fig. 13b are shown in Fig. 15. The pores at the interface appear to grow into the substrate, as illustrated by the pore to the right of the non-etching zone (arrow in Fig. 15a). To the left of the non-etching zone a larger pore is seen in which an oxide layer covers the surface on the coating side (Fig. 15b). The pore surface on the substrate side was serrated due to corrosion. Tiny graphite and/or oxide particles which seem to have been dislodged from the non-etching zone adjacent to the corrosion front (arrow 1) can be seen in front of the serrated area in the higher magnification of the BSE image. The non-etching zone beneath the corrosion front includes a dispersion of fine precipitates (arrow 2).

**Figure 15.** SEM images of an extended pore and underlying non-etching zone: (a) SE image and (b) BSE image of large rectangular area in (a)

BSE images of the area close to the corrosion front confirmed that fine precipitates were present in the non-etching zones (Fig. 15b), consistent with enhanced carbon transfer from the interfacial pore to the substrate. From a thermodynamic point of view carbides would form in distinct layers with increasing distance from the carbon source in the sequence  $M_3C_2$ ,  $M_7C_3$ , and  $M_{23}C_6$ , depending on the local carburizing potential [25]. EDS line scans and area analyses revealed that a part of the non-etching zone was a high carbon area in which the Cr and Ni concentrations were significantly decreased. Internal oxidation was observed with the formation of chromium-rich and/or silicon oxides in the non-etching zone. The decrease of chromium and nickel in the white zone was probably due to migration of these elements toward the interface and their involvement in corrosion reactions lead to the formation of oxides in the interconnected pores. BSE imaging from the serrated surface of the pore revealed the formation of flakes of oxide and/or graphite at the corrosion front (Fig. 15b). The formation of oxide or graphite in this way would be accompanied by volume changes which would lead to disintegration of the surface of the metal grain, the mechanism of attack proposed for high alloy metals [22, 25–28]. The formation of small metallic particles would in turn catalyze deposition of graphite and may therefore explain the formation of coke in the pores that eventually led to local eruptions on the coating surface.

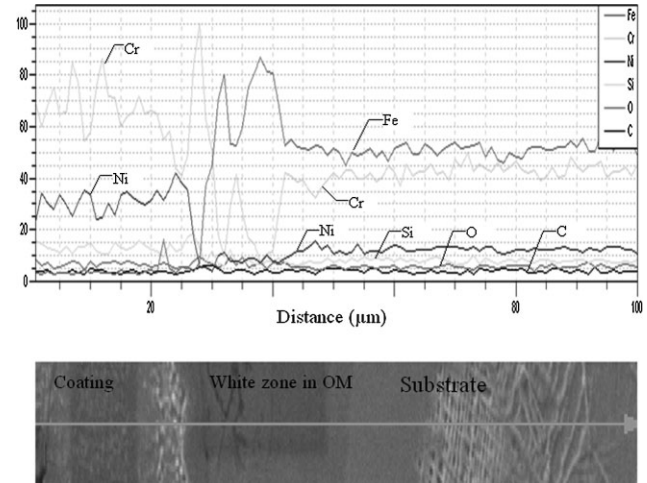
rectangle in Fig. 15a). As shown in Fig. 16, this indicated that the Cr content increased at the interface, but had been depleted to a depth of approximately  $10\ \mu\text{m}$  into the substrate and  $5\text{--}10\ \mu\text{m}$  into the coating. Ni was also depleted to a depth of  $\sim 10\ \mu\text{m}$  into the substrate. A band of Fe was detected  $\sim 5\ \mu\text{m}$  into the coating (the light areas). The dark bands in this Cr- and Ni-depleted areas of the substrate may be Cr- and/or Si-rich oxides. Although microstructural changes can be observed farther into the substrate, no changes in chemical composition were evident.

**Figure 16.** The EDS line scan analysis normal to the interface in the C1 specimen exposed for 504 h

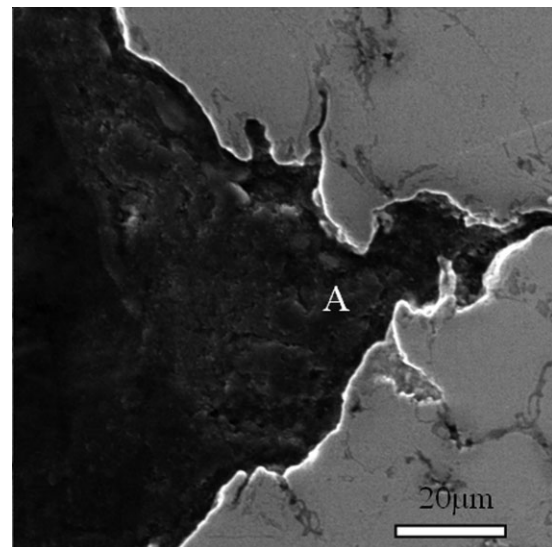
Figure 17 shows a higher magnification image of the area of the coke-filled pore marked by the white square 1 in Fig. 14b. The EDS analysis of the area A in Fig. 17 found the composition to be predominantly C with a small amount of Fe (98.3C–1.7Fe (wt%)).

Although this area of pore was relatively far from the substrate, the iron content within the coke indicates that these corrosion products must have resulted from degradation of the substrate.

**Figure 17.** The area of the coke-filled pore marked by the white square 1 in Fig. 14b

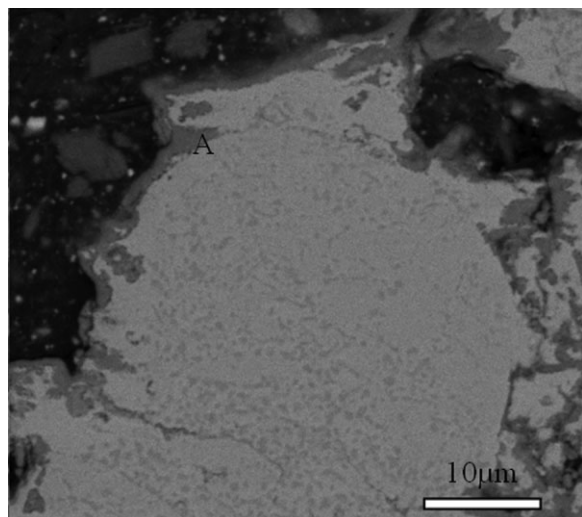
A higher magnification image of the splat marked by the white square 2 in Fig. 14b is shown in Fig. 18. An oxide layer was clearly formed over all surfaces to which the atmosphere had access. A complex chemical composition for the oxide layer at A was found by EDS analysis (70Cr–13Ni–8O–3.2Si–2.7C–1.2Mn–0.9Fe (wt%)). It is thought that this analysis represents an average of a fine mixture of Cr- and Si-rich oxides, remnant metallic phases, and/or carbides. No clear evidence of carburization of the splat is observed.

Figure 18. The area marked by the white square 2 in Fig. 14b

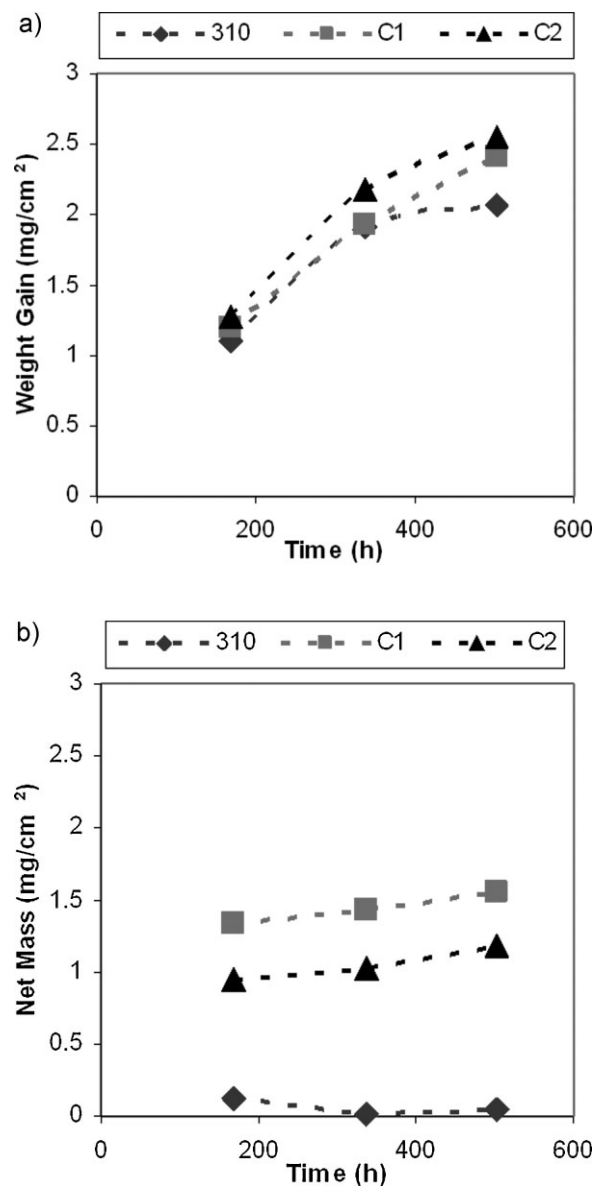
exposures and before ultrasonic cleaning (Fig. 19a) and (2) net mass changes which were obtained after ultrasonic cleaning of the specimens (Fig. 19b). The former was mainly due to the formation of external and internal (inside pores) carbon deposits. The latter did not include the loose and powder carbon deposits and so includes adherent surface deposits, internal carbon deposits, and carbon and/or oxygen dissolved into the alloy as well as weight loss due to spallation.

The mass gains were relatively moderate for the coating systems and uncoated 310S alloy, ranging between 1 and 2.5 mg/cm<sup>2</sup>. The C2 coating system showed more mass gain than that of the C1 coating system in all intervals. This was consistent with the observations of the extent of surface blackening and formation of powdery carbon deposits. However, the coke protrusions on the edges and plan surfaces of the C2 coating

system were much shorter and less numerous than for the C1 coating. In general the weight gain trends did not exhibit the abrupt increase which is often encountered in metal dusting with longer exposure times. This indicated that metal dusting damage was not extensive in any of the specimens during the 504 h exposure. The positive net mass changes after ultrasonic cleaning of specimens confirmed the lack of significant spallation for all of the specimens (Fig. 19b).

The weight gains in the coated specimens were partly due to deposition of carbon products in the interconnected pores within the coating and inside the erupted areas. The weight increase due to oxidation/carburization and losses due to scale spallation and/or dusting may affect the net mass change results slightly. The net mass change of the C1 specimen was more than that of the C2 specimen. This could be related to the higher level of intrinsic porosity within coating 1 and therefore more deposition of corrosion products inside the pores.

Figure 19. Graphical representation of the (a) weight gains and (b) net mass changes measured for the exposed coatings and uncoated 310S alloy specimens

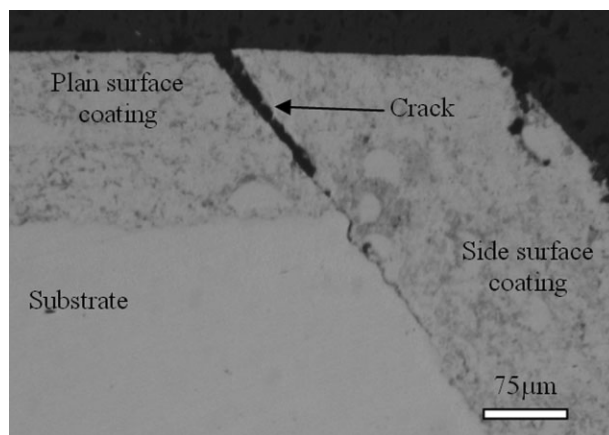
**Figure 21.** A crack formed at the interface of the plan and side surfaces of the C2 coating after 168 h exposure
