Experimental and analytical investigation of dynamic crack patterns in automotive windshield sheets subjected to low velocity impact

Abstract

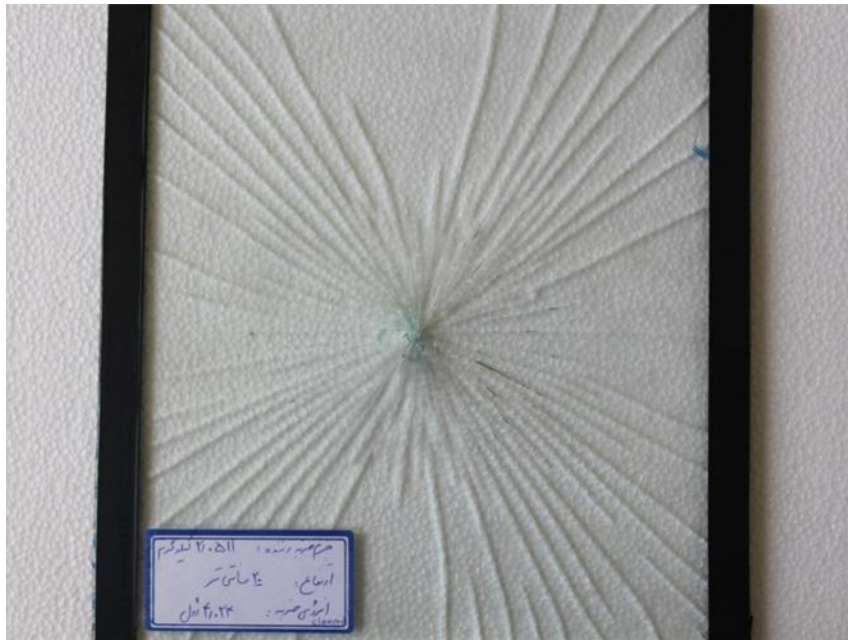
Fig4..specimen after test code D-B-T-1

Laminated glass specimen after test code D-B-T-1 is shown in Fig. 4.

As it is observed from Fig. 4, the impact region at the center of specimen is a circle with approximate diameter of 3mm. Indeed, due to low energy of impact, the impactor has not caused remarkable damage at the impact area. In addition, the impactor has not penetrated in the specimen and damage is superficial. As a matter of fact, the impact energy has been released through radial cracks propagation and the impactor has not had any penetration in the specimen.

It can be inferred from Fig. 4 that the radial cracks in test code D-B-T-1 are nearly symmetrical and about 67 from which this quantity, 60 cracks have been extended to the borders of specimen and released their energy

through reaching the border of specimen. As a consequence, the damage mode is dynamic crack propagation. In this specimen, no circumferential crack is observed which can be due to low level of impact energy. Consequently, it seems that although all the impact procedure occurs in less than some milliseconds, radial cracks are made at the first stage. At the vicinity of impact region, some sectors of circles are observed which are distributed sporadically to the approximate radius of 6mm from the center of specimen. Moreover it can be seen from Fig. 4 that the radial cracks have been propagated from the impact surface of laminated glass. On the other hand, the radial cracks in this specimen are superficial and have not reached the lower surface of specimen, hence it can be understood that the fracture of laminated glass begins with superficial cracks at the upper surface of specimen.
