Experimental and analytical investigation of dynamic crack patterns in automotive windshield sheets subjected to low velocity impact

P. Shojaei Shahmirzadi, H. Saeidi Googarchin*

Automotive Fluids and Structures Analysis Research Laboratory, School of Automotive Engineering, Iran University of Science and Technology, Tehran 16846-13114, Iran

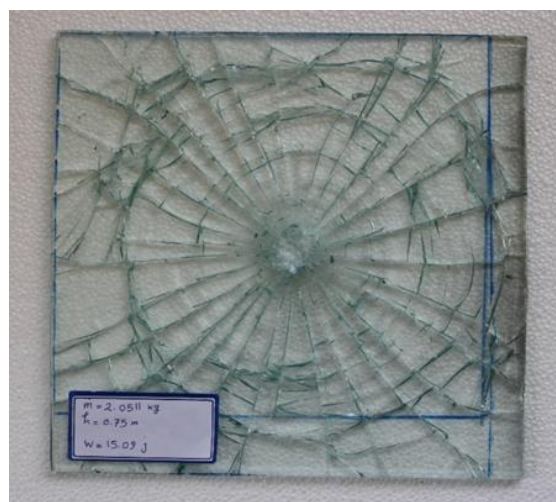
Fig12. .specimen after test code D-B-T-5

Laminated glass specimen after test code D-B-T-5 is shown in Fig.12.

As it is observed from Fig.12, the impact region at the center of specimen (powdering region) is a circle with approximate diameter of 20mm in which cracks density and consequently damage level is higher than the other regions of specimen. The projectile has penetrated to the depth of 4mm of the laminated glass, indeed the upper layer glass has fractured and PVB interlayer has elongated, but no tearing is observed. At the center of test code D-B-T-5 laminated glass, penetration depth has increased in comparison to test codes D-B-T-4 and D-B-T-3. Total number of circumferential cracks of the specimen is 5 which are placed at 47, 70, 80, 90 and 105mm distance from the center. At the vicinity of borders (close to clamping spots), net shaped diagonal cracks are more congested. Cracks have been propagated from the impact surface of laminated glass. At all 4 sides of the specimen, diagonal asymmetrical net shaped cracks have been made. At both upper and lower glass layers, radial cracks converge at the center of the specimen and their divergence increases at larger radiuses. Most of radial cracks have reached the borders of specimen and released their internal impact energy by this way.
