Experimental and analytical investigation of dynamic crack patterns in automotive windshield sheets subjected to low velocity impact

Off-road cars' windshields are vulnerable to different types of stones, road debris and pebbles due to common off paved and gravel surfaces in which they drive. Any attempt to design windshield that minimizes injury and death of occupants during a vehicle accident requires a thorough understanding of the mechanical behavior of automotive windshield subjected to foreign object impact loads.

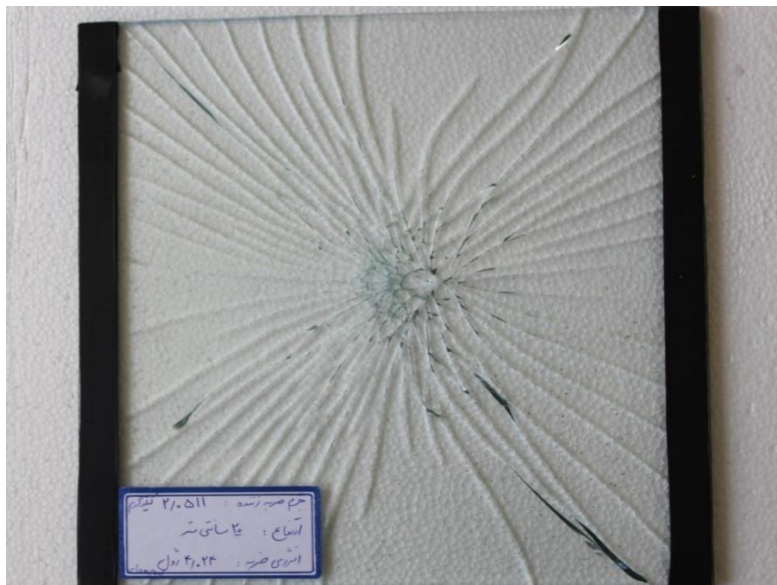
Fig6..specimen after test code D-B-T-2

Laminated glass specimen after test code D-B-T-2 is shown in Fig.6

Like test code D-B-T-1, no circumferential crack is observed at the specimen. The results of this test are akin to the test code D-B-T-1, just 2 differences are observed:

There are 62 radial cracks which is five number less than test code D-B-T-1.

The damage region at the center of specimen in test code D-B-T-2 is a bit larger than the counterpart region in test code D-B-T-1.

Indeed, some part of failure mode has been transformed to powdering failure mode.
