# Corrosion resistance of Ni-50Cr HVOF coatings on 310S alloy substrates in a metal dusting atmosphere

J. Saaedi\*, H. Arabi, T. W. Coyle, S. Mirdamadi and H. Ghorbani

Metal dusting attack has been examined after three 168 h cycles on two Ni-50Cr coatings with different microstructures deposited on 310S alloy substrates by the high velocity oxy-fuel (HVOF) thermal-spray process. Metal dusting in uncoated 310S alloy specimens was found to be still in the initiation stage after 504 h of exposure in the 50H<sub>2</sub>:50CO gas environment at 620 °C. Dense Ni-50Cr coatings offered suitable resistance to metal dusting. Metal dusting was observed in the 310S substrates adjacent to pores at the interface between the substrate and a porous Ni-50Cr coating. The porosity present in the as-deposited coatings was shown to introduce a large variability into coating performance. Carbon formed by decomposition of the gaseous species accumulated in the surface pores and resulted in the dislodgement of surface splats due to stresses generated by the volume changes. When the corrosive gas atmosphere was able to penetrate through the interconnected pores and reach the coating–substrate interface,

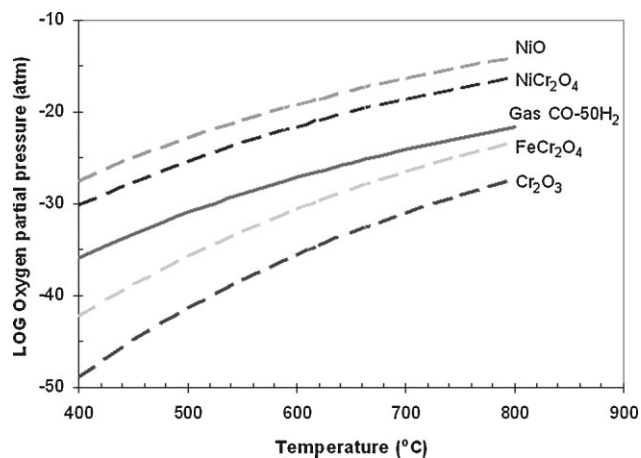
**Figure 20.** Thermal stability of spinels,  $\text{Cr}_2\text{O}_3$ , and NiO phases

Based on the initial chemical compositions of the substrate and coating given in Table 1, the  $\text{Cr}_{\text{eq}}$  (as defined by Schillmoller [7]) of the coating alloy would be  $\sim 53\%$ , which is about 2 times the  $\text{Cr}_{\text{eq}}$  of the substrate alloy. Therefore the integrity of the protective oxide scale formed on the Ni-50Cr alloy would be expected to be higher than that formed on the 310S alloy because more scale-forming elements would be available to heal the protective oxide layer if any damage occurred. In the case of materials forming a protective oxide scale, metal dusting attack starts locally and often leads to formation of hemispherical pits and holes, from which coke grows in various forms [3, 20]. Oxide films formed on the surfaces of the coated and uncoated samples from the early stages of exposure as indicated by the interference colors, EDS results, and XRD patterns, consistent with the oxygen

partial pressure in the exposure environment ( $3.17 \times 10^{-27}$  atm, see Fig. 20). Numerous small areas of thin localized carbon deposits (black stains or black spots) formed on all the specimens (Figs. 2d–f and 4a), but did not develop into the hemispherical pits generally associated with the beginning of metal dusting attack, even after 504 h of exposure.
