FATIGUE BEHAVIOUR OF A ROLLED AZ31 MAGNESIUM ALLOYS PREPARED BY EP AND BB CONDITIONS

Abstract: Rotating bending fatigue tests have been performed using smooth specimens of a rolled AZ31 magnesium alloy in laboratory air at ambient temperature. Fatigue strength and characteristic was evaluated and fracture mechanism was discussed on the basis fracture surface analysis. Electrical polishing (EP) as well as deep rolling (ball burnishing (BB)) U-notched specimens were performed on two groups of samples, to evaluate optimum conditions for fatigue life. The microstructure and tensile properties of roll cast (RC) Mg- 3% Al- 1% Zn (AZ31) was investigated. The fatigue strength of 107 cycles around 100 MPa for deep rolling while it was around 40 MPa for Electrical polishing. It was very important to understand the effect of (ball burnishing (BB)) conditions on the hardness of the surface through to the core. The two procedures improved the fatigue performance, but better improve in results were found in ball burnishing. The growth of small cracks initiated at the surface coincided with the FCP characteristic after allowing for crack closure for large cracks, but the operative fracture mecha

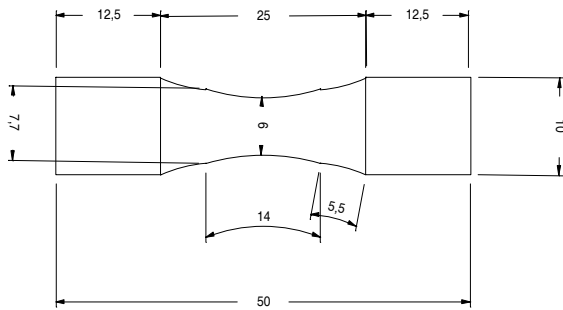
As shown in Fig. 1. Mechanical testing tensile and fatigue specimens with 5 mm diameter, 14 mm gauge length was machined from as-received so that their axis is parallel to the rolling direction. BB condition prepared with the following preparation condition on ECOROLL instrument using tool type (HG6) at 100 bar (246 N) with feed rate of 0.17 mm/min at 30 rpm.

Fig. 1. Shape and dimension of mechanical testing specimens

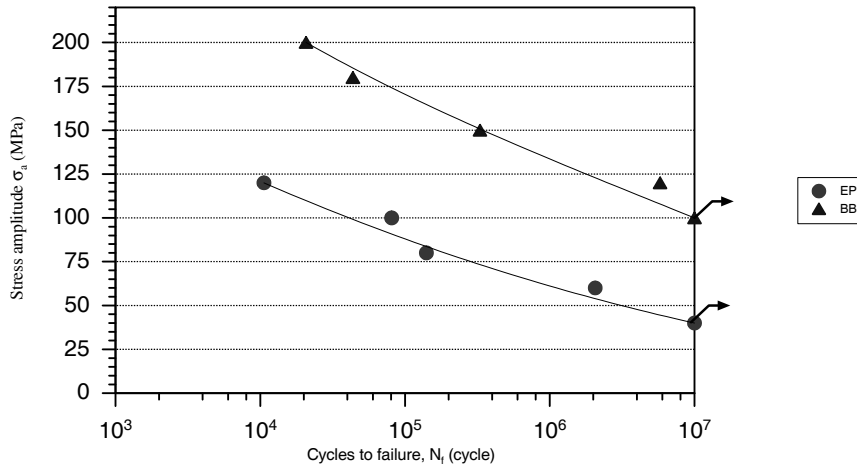
S/N curves for the EP and the BB specimens in laboratory at a stress ratio of -1 and frequency of 50 Hz (rolled magnesium alloy) in laboratory air is shown in Fig. 2. In this figure, for comparison purposes, the S–N curves of the EP and BB specimens are shown respectively. As seen from the figure, the fatigue life of the rolled magnesium alloy of EP specimen is relatively shorter than that of BB specimen. The extent bending in the S–N curve is gentler in the BB specimens than in the EP specimen. Next let us compare the S–N characteristics of the EP and BB specimens. There are great differences in the fatigue lives and in the fatigue limits, especially at higher stress amplitudes, there are differences in the fatigue lives.

Fig.2. S-N curve for rolled AZ31 at EP, BB conditions, rotating beam, R=-1, 50Hz.

4. Subsurface crack initiation occurred at applied stresses at 60 MPa. At BB condition but it can be seen for both 80 and 100 MPa stress for EP condition. The S-N diagram is shown in Fig. 2. It is well known that fatigue limit does not exist in non-ferrous alloys, thus fatigue tests were continued until 10^7 cycles. At EP condition $\sigma = 40$ MPa, fatigue failure did not occur, but non-propagating cracks were observed on the specimen surface. As can be seen in the figure, the present Mg alloy seems to possess a definite fatigue limit, which may be related to the existence of non-propagating cracks. The fracture mode depending

1. Fatigue strength at 10^7 cycles was 100 MPa

for BB condition with the following preparation condition on ECOROLL instrument using tool type (HG6) at 100 bar (246 N) with feed rate of 0.17 mm/min at 30 rpm. While the fatigue strength at 10⁷ cycles was 40 MPa for EP condition.

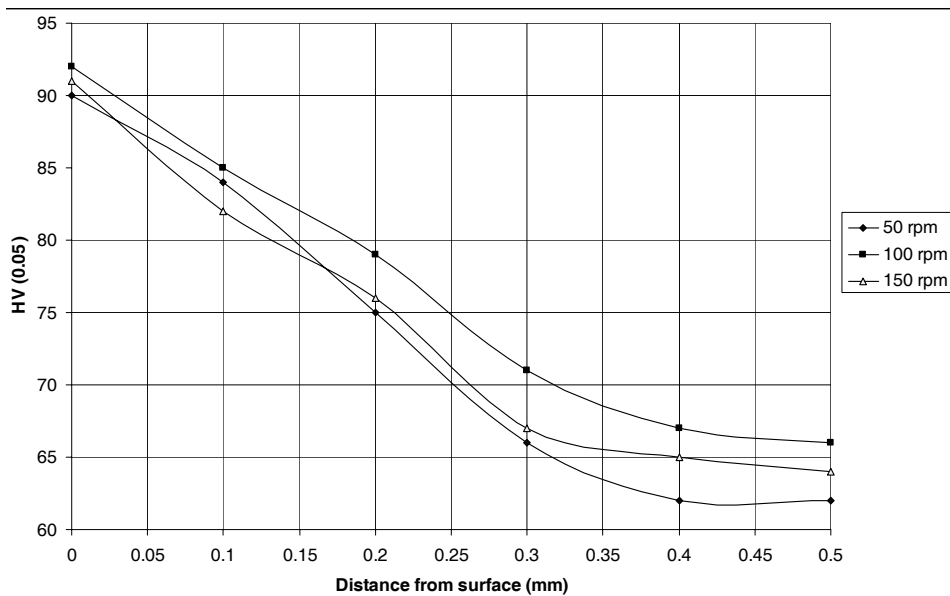
3. 3. A different experiment were used to investigate the best condition for BB (pressure, feed rate, speed) as example for tool HG3 200 bar (123 N) for 50, 100 and 150 rpm. The microhardness measurement from the surface in Fig. 3. Shows that the suitable condition for using 200 bars is 100 rpm for AZ31 as the hardness decreased from the circumference gradually to the center.

Fig. 3. Microhardness profile of AZ31 after BB at 200 bars, 0.17 mm/min at different BB rotation speed.

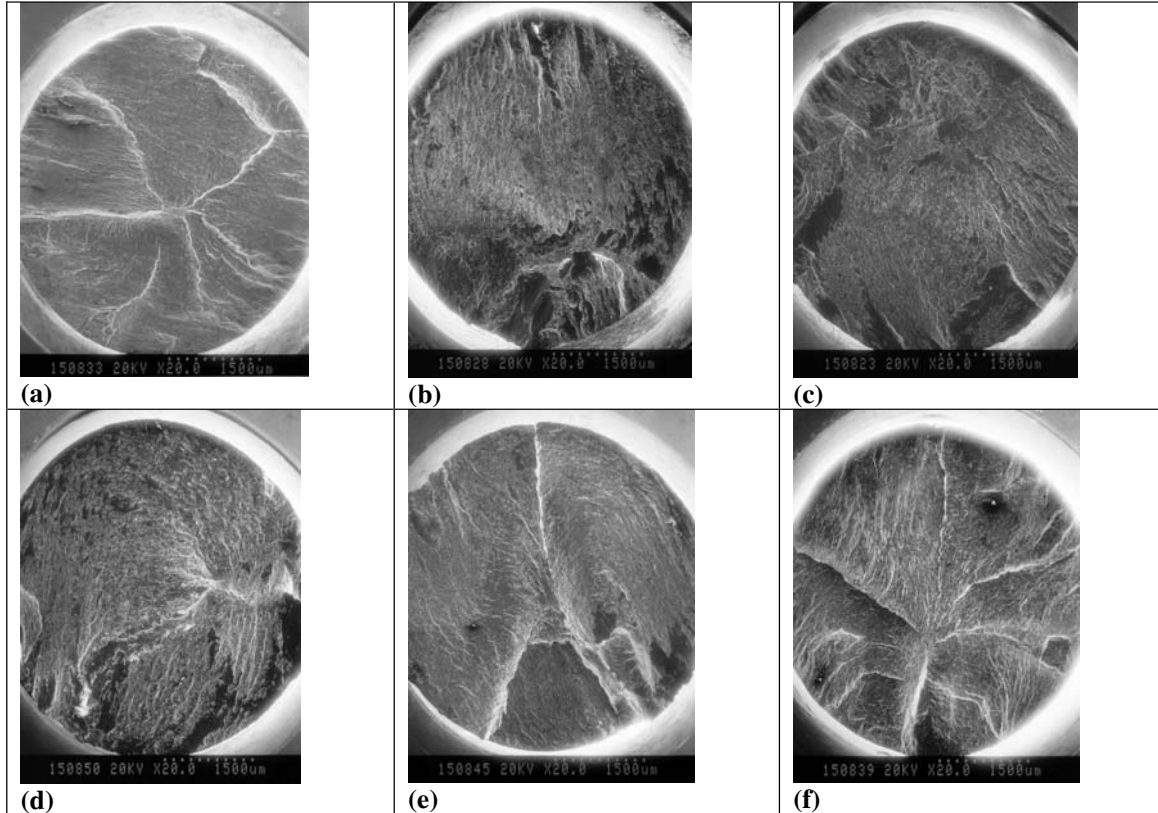
The fracture surface of AZ31 for EP condition and BB condition at different stress is shown in Fig.

Fig.4. SEM micrographs showing fracture surfaces at difference stress for EP at (a) 60MPa; (b) 80 MPa; (c) 100 MPa and BB at (d) 60MPa; (e) 80 MPa; (f) 100 MPa.

on applied stress level, above 60 MPa cracks initiate at the surface (surface fracture), while below that stress at the interior of the specimen (subsurface fracture). Subsurface fracture is a very interesting finding, which has not been recognized in Mg alloys, for both EP and BB conditions.

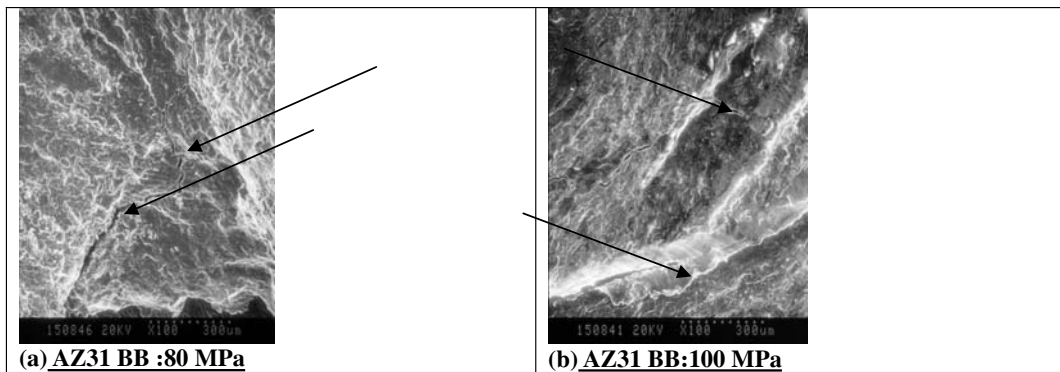
Fig. 5. SEM micrographs showing cracked surfaces at difference stress for BB at (a) 80MPa; (b) 100 MPa

The cracked line could be seen easily for higher stress for BB condition as fracture occurs in internal surface not at the outer surface as in the EP condition in Fig. 5.
